Avondale Facility Statistics

Facility Description

Wetland Design

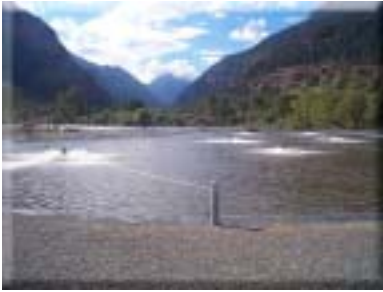
Lagoon

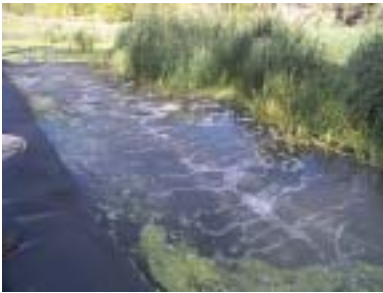
Aerated influent end of wetland

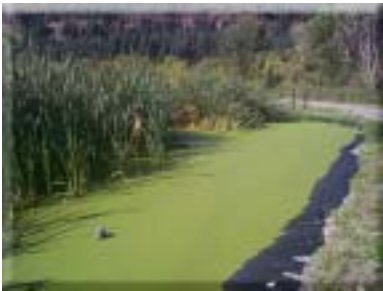
Effluent end of wetland cell

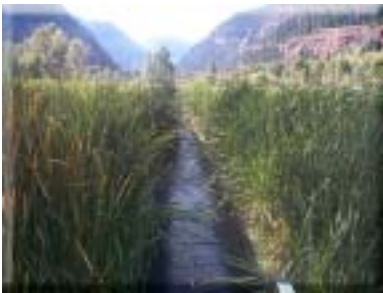
Vista down wetland cells

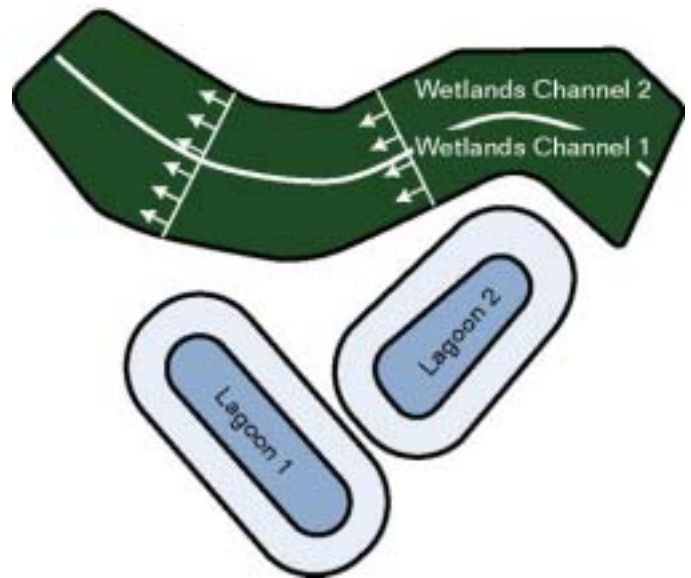
The constructed wetland consists of two 70' X 470' basins, with a maximum depth of 1.5'.

The wetland cells are contoured to fit the site topography. As shown in the schematic, the borders are curved.

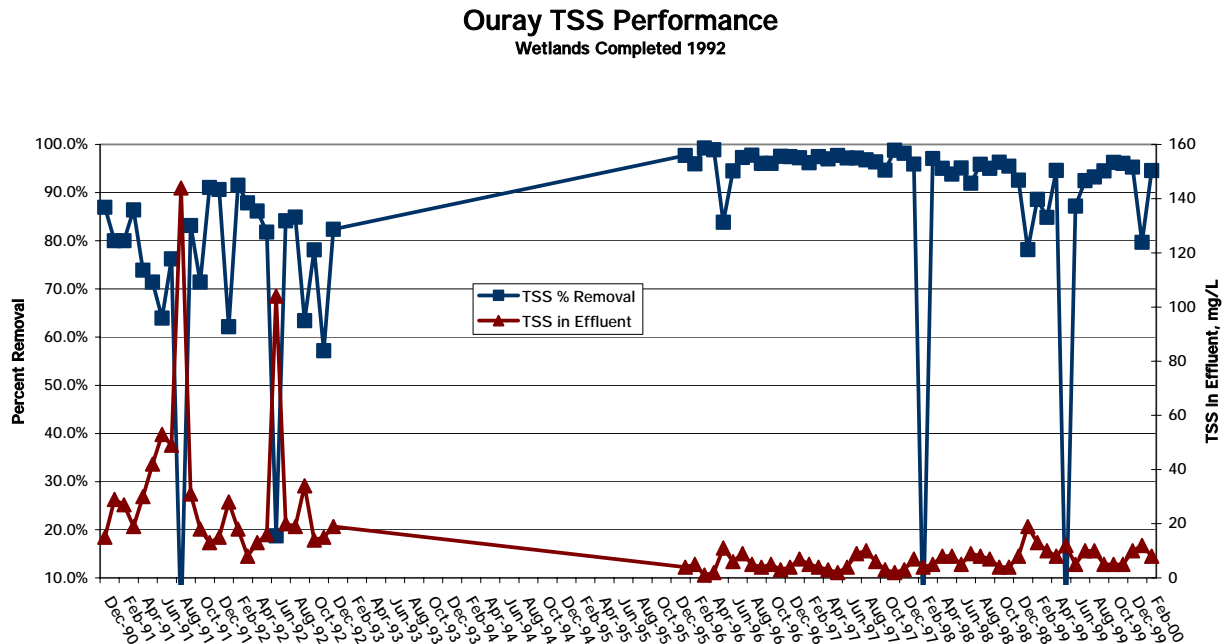
TSS Data

The TSS graph plots the percent removal on the left axis and TSS in mg/l in the effluent on the right axis. The average monthly TSS in the influent, since 1996, has been 139 mg/l and the average monthly effluent has been 7 mg/l. This clearly meets the permit discharge requirement of 30 mg/l.

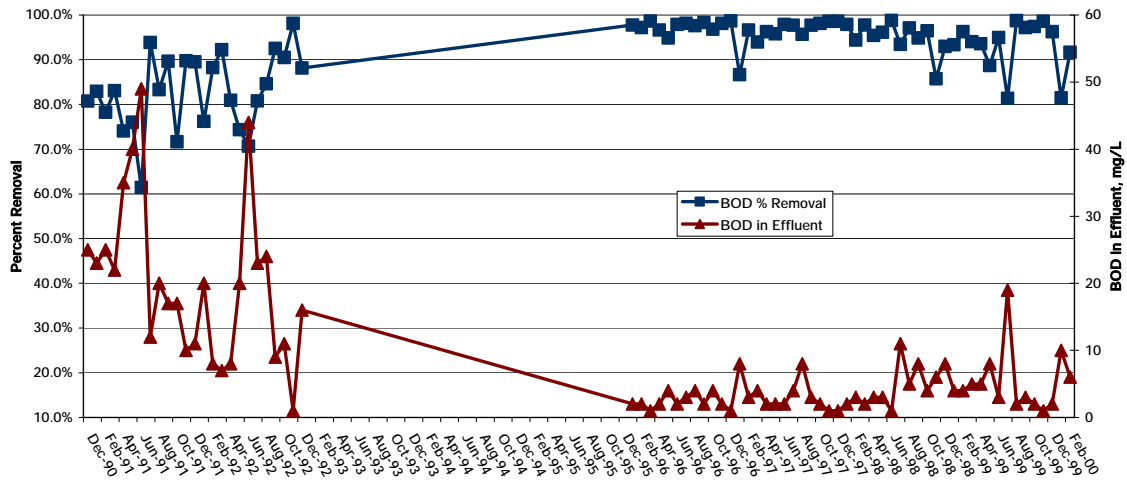
Ouray BOD Performance
Wetlands Completed 1992

The BOD data is plotted similarly to the TSS data, with mg/l in the effluent on the right axis, and percent removal on the left axis. . The average monthly influent amount has been 96 mg/l and the average monthly effluent amount has been 4 mg/l.

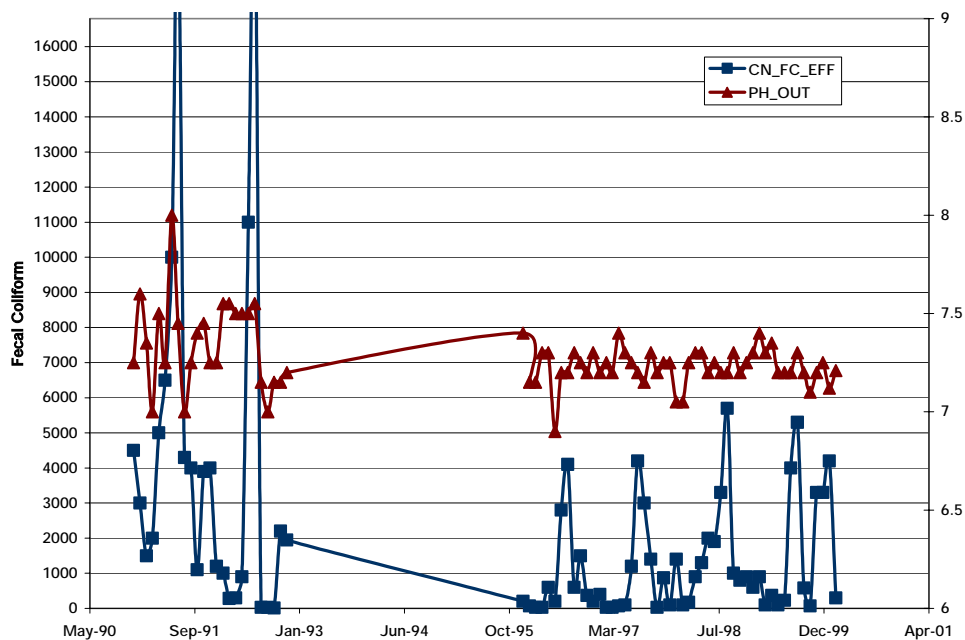
Ouray pH and FC in Effluent

Data for these two categories has been plotted on the same graph. Data reflect the quality of the effluent, not influent measurements are taken for these parameters. The pH values plotted are an average of the minimum

The average fecal coliforms in the effluent has been 1300 organisms per 100 ml. This clearly meets the discharge permit requirements of 6,000 organisms per 100 ml.
